Wessell, Nickel & Gross Shanks & Flanges

New and Improved

The WNG Hammer Shank has been completely redesigned

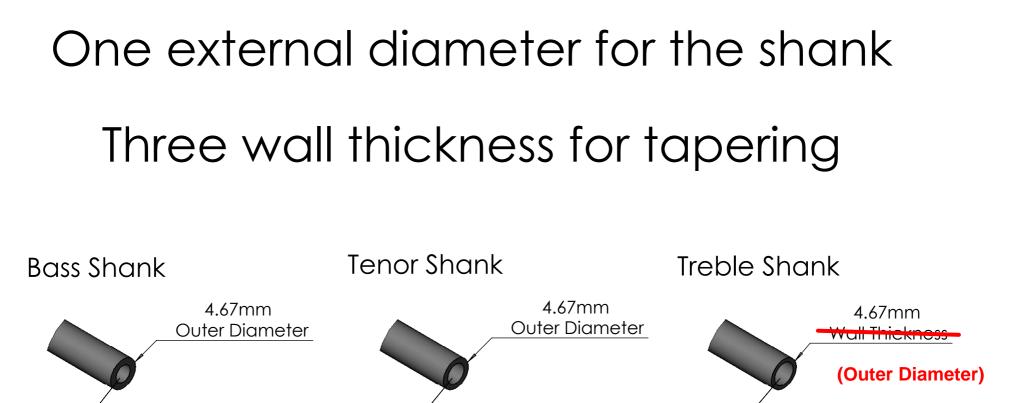
1mm Wall Thickness 0.80mm Wall Thickness

0.60mm Wall Thickness

One external diameter makes drilling and hanging hammers easier

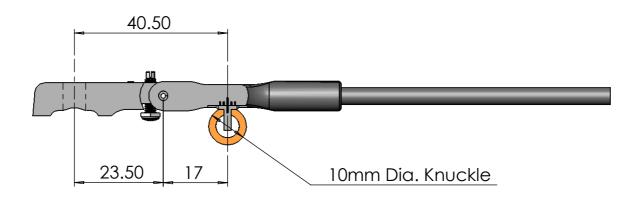
Set of 90 Part No. 06-5103

Features low leverage, a large knuckle and a New York flange
